Rockwall Terracing Philippines

Rockwall terracing refers to the piling of stones or rocks along contour lines to reduce soil erosion in hilly areas.

T_PHI049en

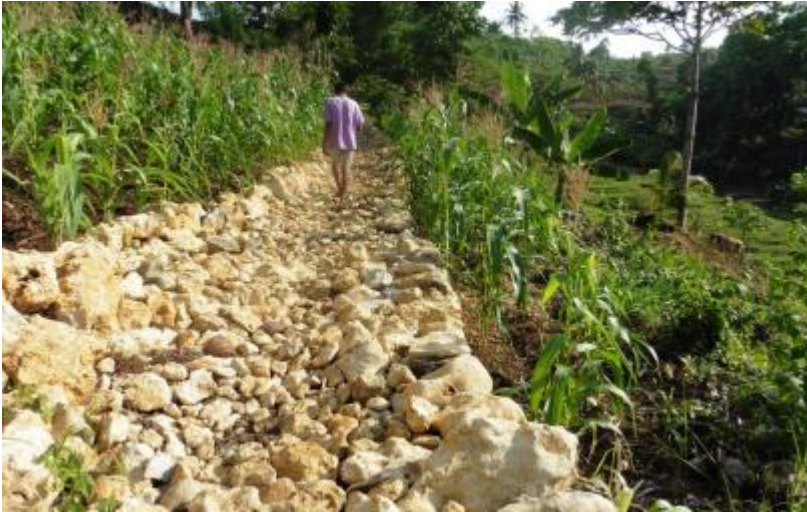
left: Piled rocks serve as pathway
(Photo: Engr. Djolly Ma. P. Dinamling)

With the aid of an A-Frame, contours are determined. Rocks and/or stones are gathered from the area and piled along contours to form walls 1.10 m wide and 1.50 m high. It requires 14 person-day for a month to construct a 50-meter rockwall with a cost of 800 USD. Maintenance of the structure is done three times a year by repiling of dislodged rocks.

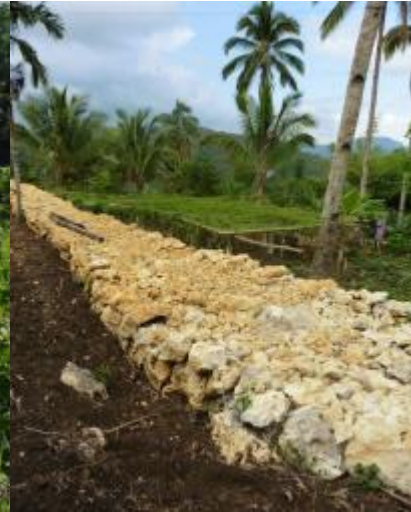
right: Rocks piled along contours.
(Photo: Engr. Djolly Ma. P. Dinamling)
