Alternate Wetting and Drying Philippines

Alternate Wetting and Drying is a water-use management technique wherein irrigation water input could be substantially reduced to as much as 35% without significantly affecting rice yields.

T_PHI059en

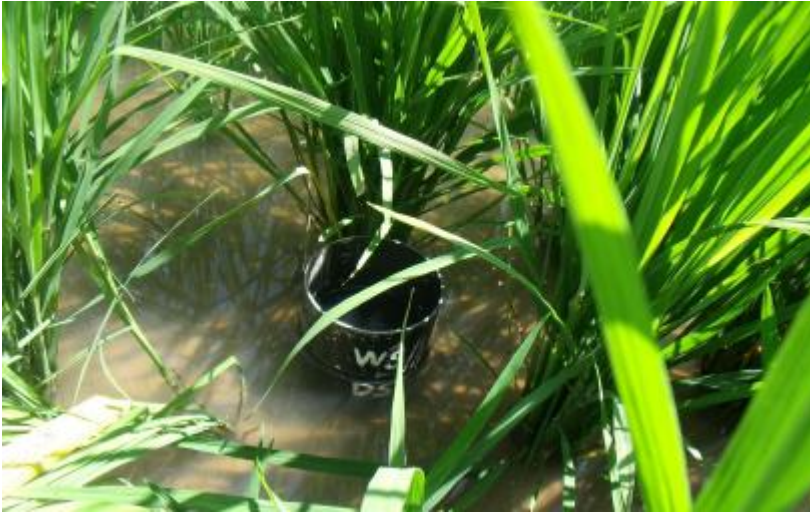
left: Flooded field with field water tube (Photo: FSSP Associated Tech)

Practical implementation of AWD is facilitated using a simple tool called a 'field water tube' as observation well, used in monitoring the water level in the field. It is made of a 25 cm long PVC pipe with a diameter of 10 to 15 cm. In some instances, bamboo can be used instead of the PVC pipe. The pipe is perforated with many holes on all sides to allow lateral movement of water in the root zone. It is installed into the soil by ensuring that 10 (dry season) or 5 (wet season) cm protrudes above the soil surface. Soil must be removed inside the tube so that the bottom is visible. During the first 21 to 30 days after direct seeding or transplanting, 2 to 3 cm of water is maintained to control weeds and to ensure that the crop has already recovered from transplanting shock. AWD is imposed after 21 to 30 days where the water in the tube is monitored. Once the water inside the tube disappears, irrigation is applied to a water depth of 5 cm above soil surface. It is noted that during fertilizer application and flowering stage, sufficient water is maintained to avoid spikelet sterility. Terminal drainage from one to two weeks before the expected time of harvest is also done to promote uniform maturity of the crop and to facilitate easement of post-harvest operations in the field.

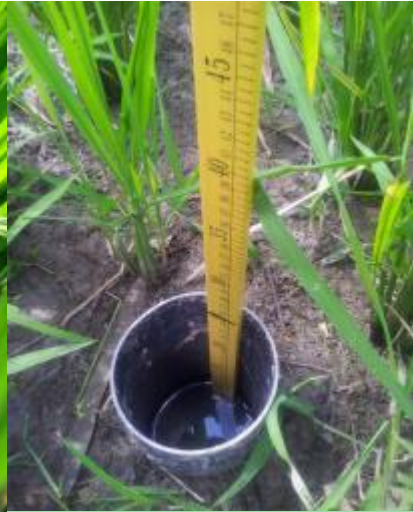
right: Measuring the water level inside the field water tube (Photo: FSSP Associated Tech)
